Firing Pin Separation and Comparison

Perazzi shooters have mentioned on discussion boards about failures to fire with some being caused by Firing Pin Separation. This document will serve to document the appearance of Firing Pin Separation, how to fix it and alternatives available to shooters.

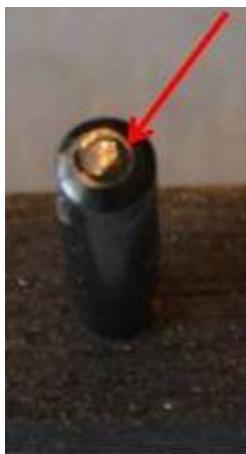
Pic 1

Examine Pic #1 and Pic #2 below, these two pictures show the most visible indicators of Firing Pin Separation. In pic #1, we see the rear of a firing pin and a visible concentric circle. The small concentric circle is the back part of the part that strikes the primer. The larger body of the firing pin has been struck by the hammer so many times it has worn such that the small part is visible. This firing pin should be changed immediately. Pic #2 shows a small oval "racetrack" shape in the recess for the firing pin lock pin. This also indicates that the two pieces are separating and this firing pin should be replaced.

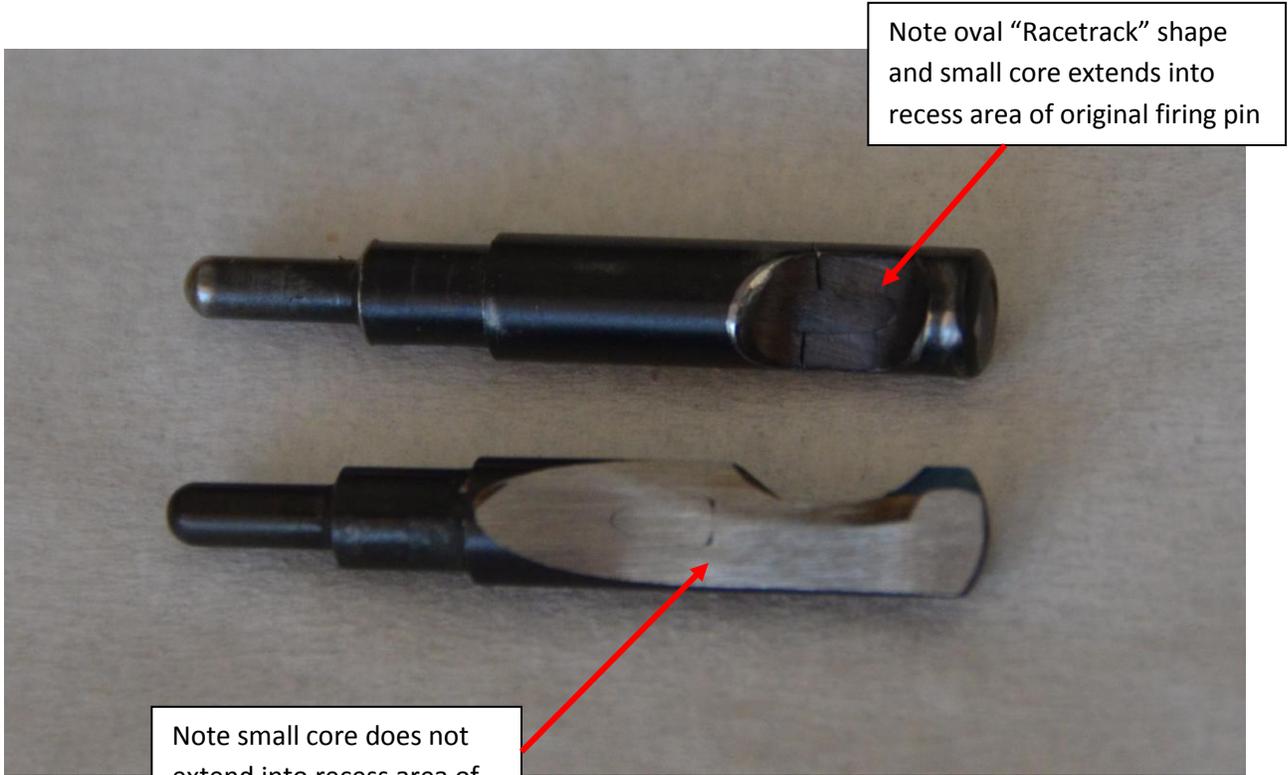
Pic #3 shows a comparison of a Perazzi firing pin that is separating and a new Giuliani firing pin that has been ground to reveal the internal construction. Note that the original firing pin has separated in a manner similar to Pic #2 above. Note on the Giuliani firing pin inner core does not extend back to the recess for the firing pin lock pin, so the small core is compressed against a considerable thicker piece of the larger firing pin body.

Note oval "Racetrack" shape and small core extends into recess area of original firing pin

Note small core does not extend into recess area of Giuliani firing pin
